Analysis of the T63-A-700 Engine used in Alcohol Turbine Fuel Extender Test

John S. Glaeser
Depot Engineering and RCM Support Office
U.S. Army Aviation Systems Command
Naval Air Station, Corpus Christi, Texas

August 1990

DOT/FAA/CT-TN90/18

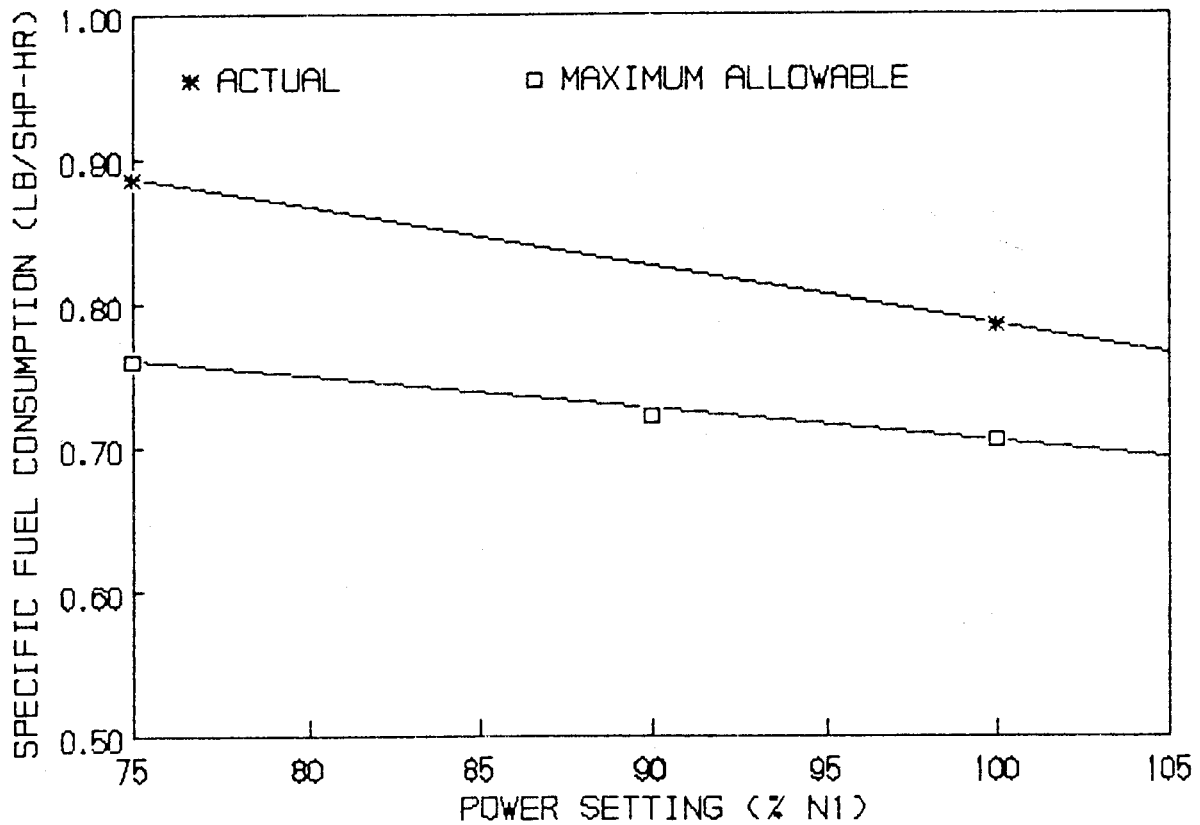
FIGURE 1. FUEL CONSUMPTION COMPARISON

The specific fuel consumption for the engine was consistently higher than the maximum allowable (figure 1).

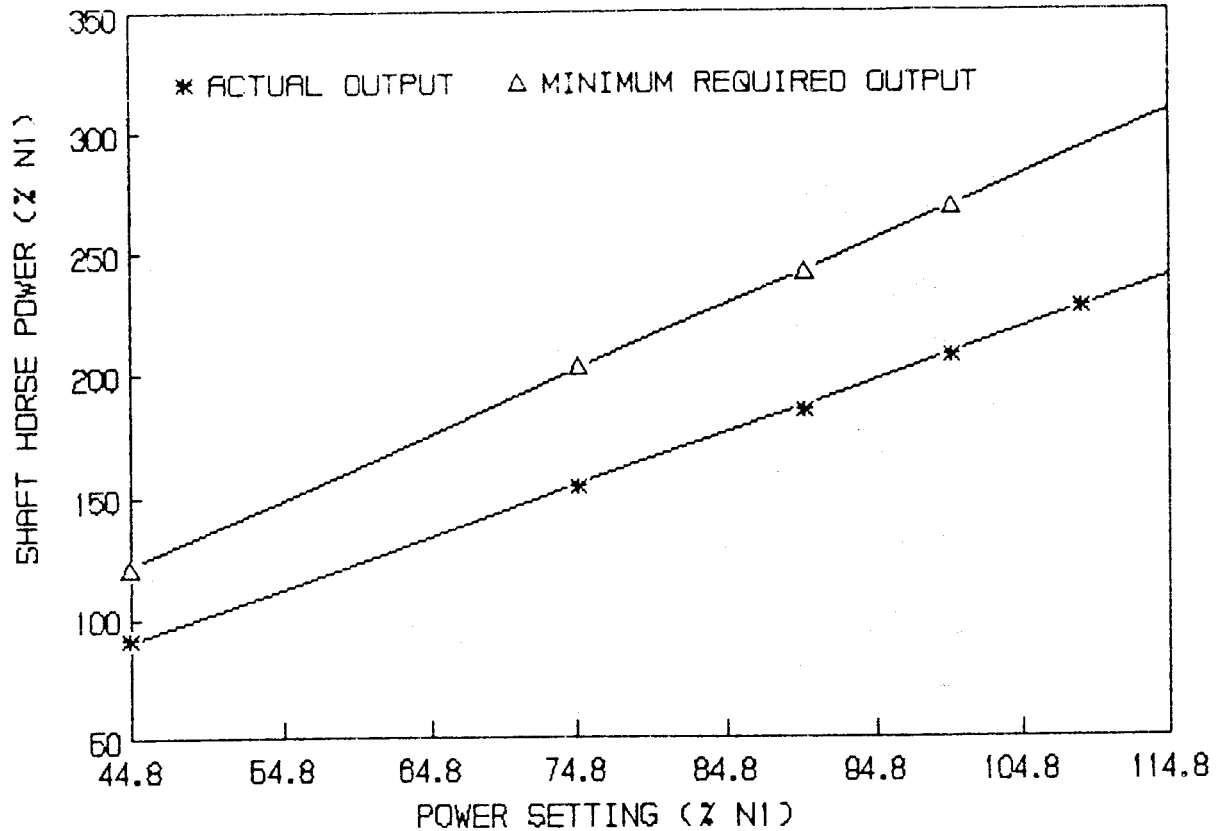
FIGURE 2. OUTPUT POWER COMPARISON

The engine was operated through all ranges of power settings. Table 2 reflects the test run parameters. At all power settings, the shaft horsepower (referred to standard day, sea level conditions) was lower than the minimum specified in TM55-2840-231-23, Aviation Unit and Intermediate Maintenance Manual, Engine Assembly (figure 2).

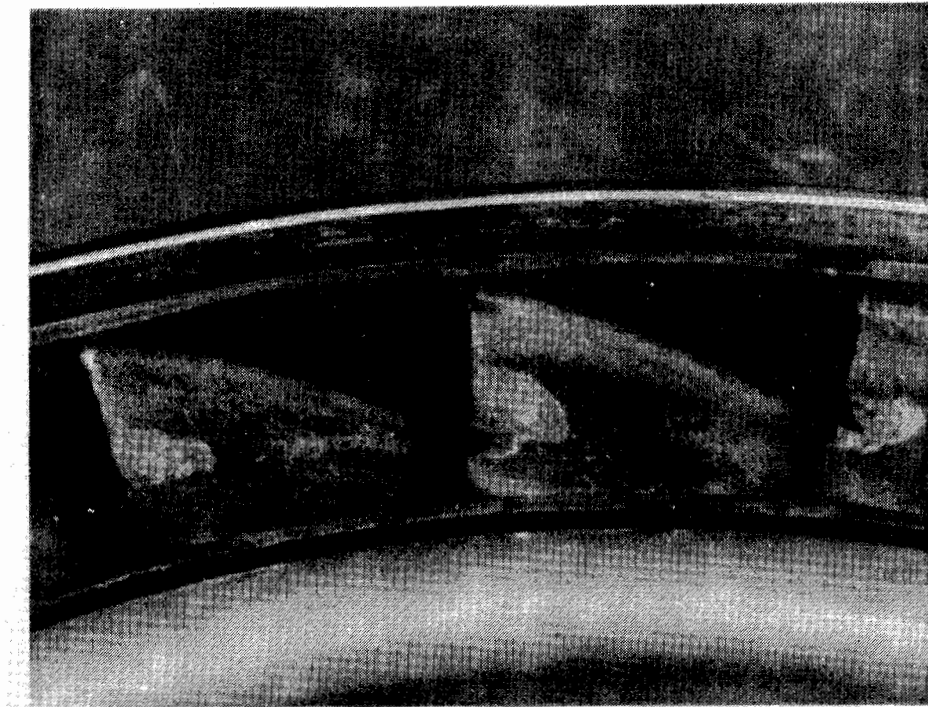
FIGURE 3. THE AFFECTED TRAILING EDGES

It was concluded that the vanes on the first stage gas producer burned during a series of hot or hung starts using extender fuels. The inefficiency of both the fuel nozzle and the fuel control unit using alcohol blends during starting operations caused the overtemperatures.

The engine disassembly revealed several discrepancies in the hot section. The first stage gas producer nozzle vanes had burned trailing edges. One 3-vane section of the nozzle was burned more heavily than the remainder of the vanes (figure 3).

Assuming that the alcohol blends contributed to the hot section damage during starting operations, it follows that consideration should be given to using only jet fuel to start gas turbine engines. Extender fuels would be introduced after the engine reached normal operating conditions. This would require additional testing to confirm the above assumption. The Federal Aviation Administration Technical Center reported that the incidence of hung starts was reduced by starting the test engine on either neat Jet-A or neat JP-4.
